TECHNICAL REPORT REMR-CO-7

**METHODS TO REDUCE WAVE RUNUP AND  
OVERTOPPING OF EXISTING STRUCTURES**

John P. Ahrens

Coastal Engineering Research Center

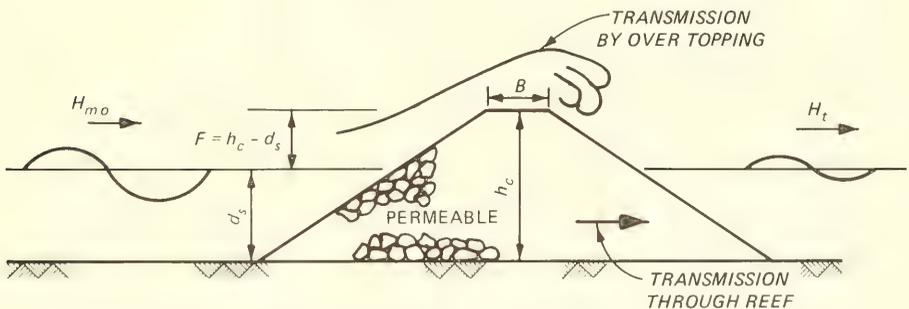
Figure 1. Definition sketch for wave transmission over and through a reef breakwater

7. To use the reef breakwater transmission model to predict either the transmission coefficient or the transmitted wave height, the following information is required: the incident zero-moment wave height  $H_{mo}$  \*; the period of peak energy density of the incident wave spectrum  $T_p$ ; the crest height of the reef  $h_c$ ; the water depth the reef is sited in  $d_s$ ; the cross-sectional area of the reef breakwater  $A_T$ ; the median stone weight used in the reef breakwater,  $W_{50}$ ; and the unit weight of the stone  $w_r$  (Figure 1). Since all of this information is required it means that the influence of all of

these variables on wave transmission can be investigated and that the model is realistic in recognizing that all of these variables play a role in the transmission process.

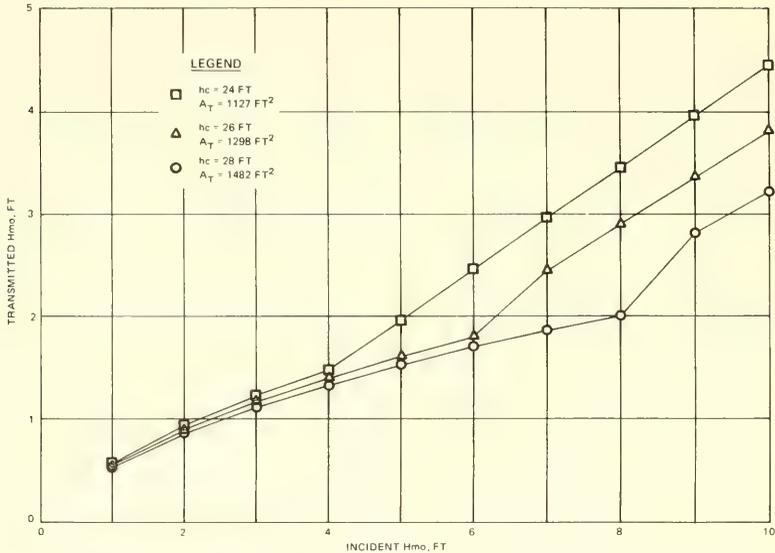
Figure 2. Transmitted wave height versus incident wave height for reef breakwaters, in a water depth of 20 ft, exposed to incident wave spectrum with period of peak energy density of 8.0 sec

8. At this point it is necessary to consider how the model might be used to evaluate potential repair or rehabilitation strategies. Figure 2

shows the transmitted wave height versus the incident wave height for reef breakwaters in 20 ft\* of water with crest heights of 24, 26, and 28 ft respectively, the period of peak energy density of the incident spectrum being 8.0 sec and the stone having a median weight of 5,000 lb with a unit weight of 165 lb/ft<sup>3</sup>. The three different crest heights shown in Figure 2 could be regarded as representing three different states of repair of the same breakwater such as the initial, deteriorated, and severely deteriorated, respectively. If the crest height of 24 ft represents the current state of the structure, then the reduction in transmitted wave height that can be achieved

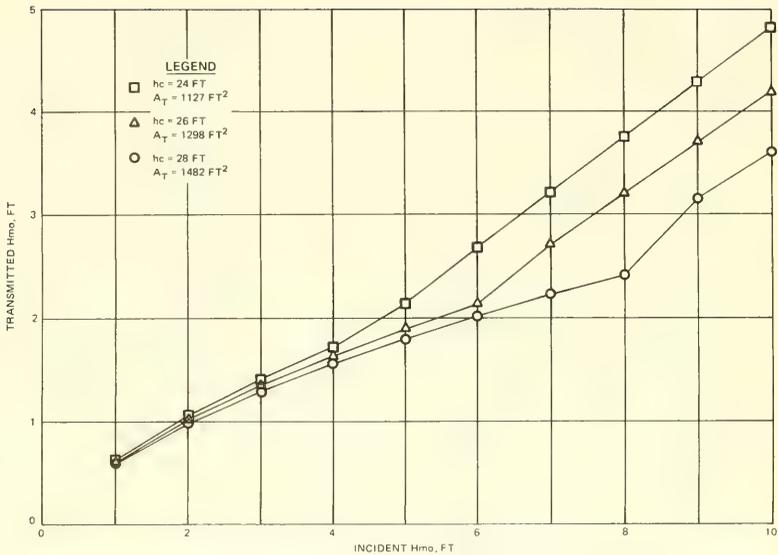
Figure 3. Transmitted wave heights versus incident wave height for reef breakwaters, in water depth of 20 ft, exposed to incident wave spectrum with period of peak energy density of 12.0 sec

9. Figure 3 shows trends generated by the reef transmission model similar to those shown in Figure 2, except that the period of peak energy density of the incident wave spectrum was changed from 8.0 to 12.0 sec to illustrate the influence of wave period on transmission. As shown in Figure 3, the longer period tends to transmit through the structure better, and when the mode of transmission shifts at the higher incident wave heights to being dominated by overtopping, the longer period waves transmit more energy by this mode too. This occurrence leads to higher transmitted waves in Figure 3 for  $T_p = 12.0$  sec compared to the transmitted waves in Figure 2 for  $T_p = 8.0$  sec for all incident wave heights.

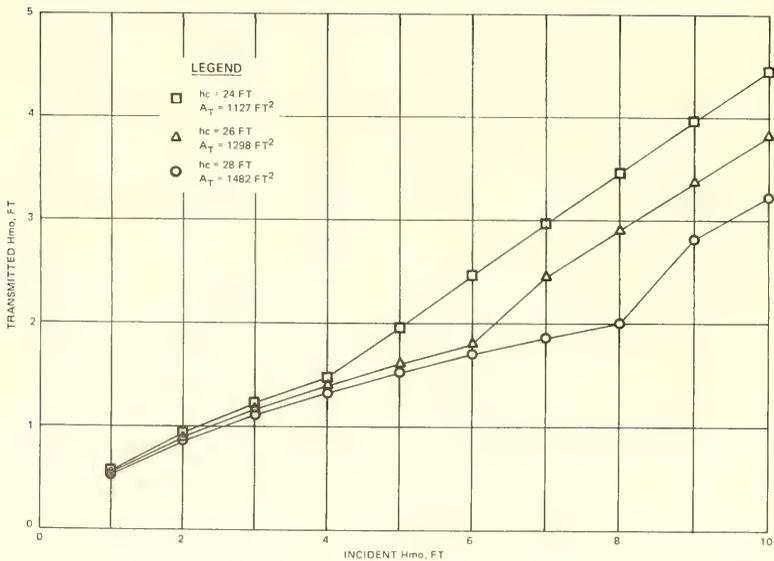
Figure 4. Transmitted wave heights versus incident wave height for reef breakwaters, in water depth of 20 ft, exposed to incident wave spectrum with period of peak energy density of 8.0 sec

10. The reef transmission model was used to generate another set of data similar to those in Figure 2 except that the median stone weight was changed from 5,000 to 8,000 lb. These results are shown in Figure 4. If Figure 4 is compared to Figure 2, it can be seen that when transmission is primarily

through the structure that the transmitted wave heights are slightly higher for the reef breakwater with 8,000-lb stone than the reef with 5,000-lb stone. This comparison illustrates that larger stones create larger void spaces which allows slightly higher transmission through the structure (all other factors being equal). When transmission is dominated by overtopping, the transmitted wave heights are about the same.

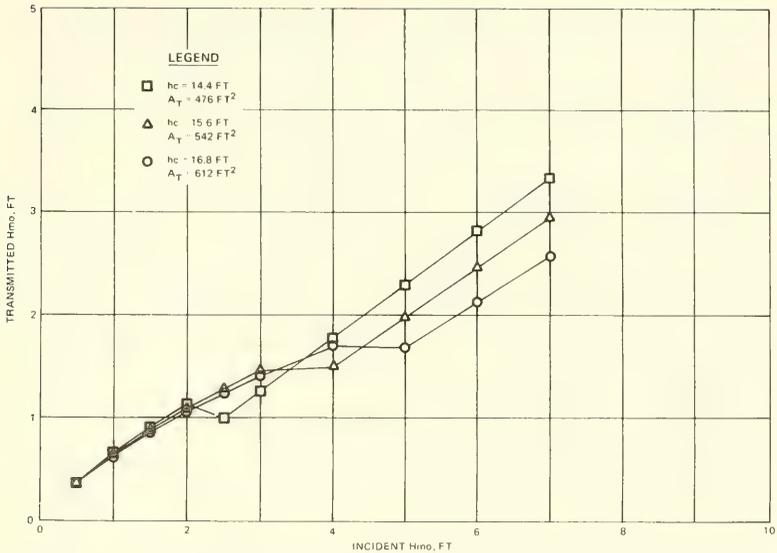
Figure 5. Transmitted wave height versus incident wave height for reef breakwaters, in water depth of 12.0 ft, exposed to incident wave spectrum with period of peak energy density of 8.0 sec

11. Figure 5 uses the reef transmission model with wave conditions and stone size the same as those in Figure 2 but with a water depth reduced from 20 to 12 ft and the crest heights of the reefs reduced in proportion to the water depths. Comparison of Figures 2 and 5 indicates that the wave transmission is slightly greater for a reef in a 12-ft water depth than it is for a reef in a 20-ft water depth because the cross-sectional area of the structure has been reduced more in changing from a water depth of 20 to 12 ft than the reduction in wave length. The cross-sectional area of the structure is important both for transmission through the reef and for transmission by overtopping. A wider structure is more effective in reducing transmission than a narrower reef breakwater with the same height. Since it might be easier to rehabilitate a structure by increasing the width rather than by increasing the height to achieve a desired level of transmission, this approach is explored using the reef transmission model in Figure 6. Figure 6 has the same wave conditions and stone size as used for Figure 2, but in Figure 6 only one crest height of 24 ft is shown having three different cross-sectional areas. The various cross-sectional areas were obtained by using crest widths of 3, 6, and 12 stone diameters which give cross-sectional areas for the reef of 1,127, 1,355, and 1,810 ft<sup>2</sup>, respectively. In Figure 2 the reef with a crest height of 28 ft (the lowest transmission trend) has a cross-sectional area of 1,482 ft<sup>2</sup>. Comparison of Figures 2 and 6 shows that the reef with a height of 28 ft and a cross-sectional area of 1,482 ft<sup>2</sup> allows less wave transmission than the reef with a crest height of 24 ft and a cross-sectional area of 1,810 ft. The comparison suggests that it is more effective to reduce transmission by repairing the reef's crest than increasing its width. Of course, other factors would have to be considered such as the relative difficulty of increasing the crest height versus increasing the cross-sectional area without increasing the crest height.

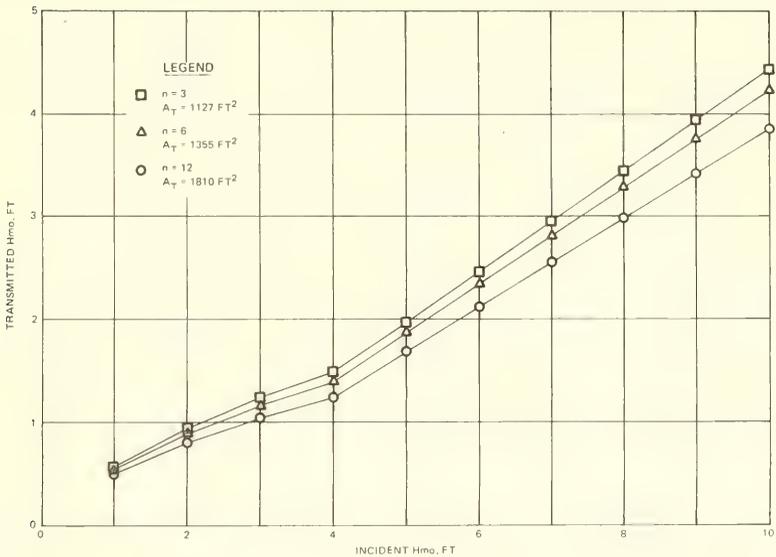
Figure 6. Transmitted wave heights versus incident wave height for reef breakwaters, in water depth of 20 ft, exposed to incident wave spectrum with period of peak energy density of 8.0 sec

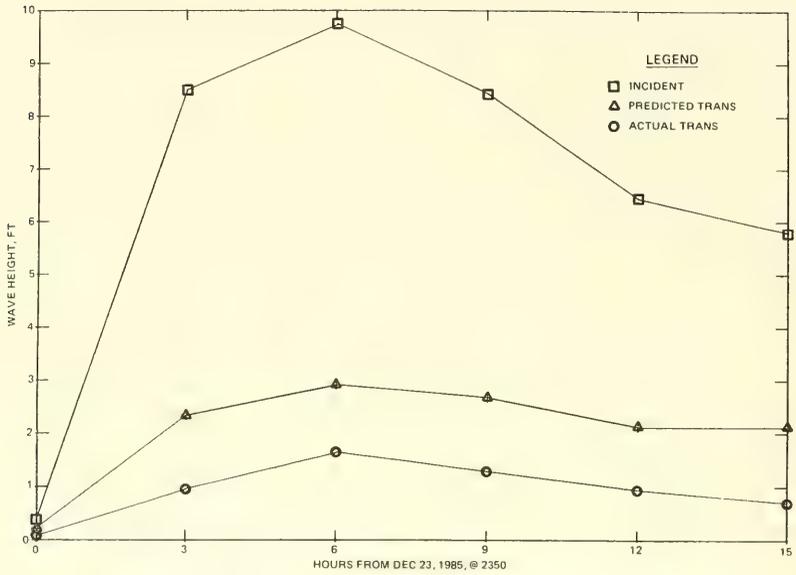
Figure 7. Incident and transmitted wave heights Burns Harbor, Indiana

12. An example of the reef transmission model applied to an existing structure is furnished by the wave transmission occurring at Burns Harbor,

Indiana, on Lake Michigan. Burns Harbor frequently experiences greater than desirable wave action in the harbor. Transmission by overtopping has increased because of high lake levels in 1985 and 1986, and transmission through the structure appears to be high due to the large size of the stone used in the armor. Unless special placement of the armor is used, large armor stone leave large void spaces, allowing greater wave transmission through the breakwater. Ahrens (1987) provides a quantitative relation for this occurrence. Figure 7 shows wave transmission caused by a storm at Burns Harbor and predicted wave transmission using the reef breakwater transmission model. Figure 8 shows wave action at the Burns Harbor breakwater generating transmitted waves in the harbor. Predicted transmission using the model is greater than the observed transmission since the reef transmission model was developed from physical model tests of very permeable rubble mounds with no core. However, the model follows the trend of the observed data quite well.

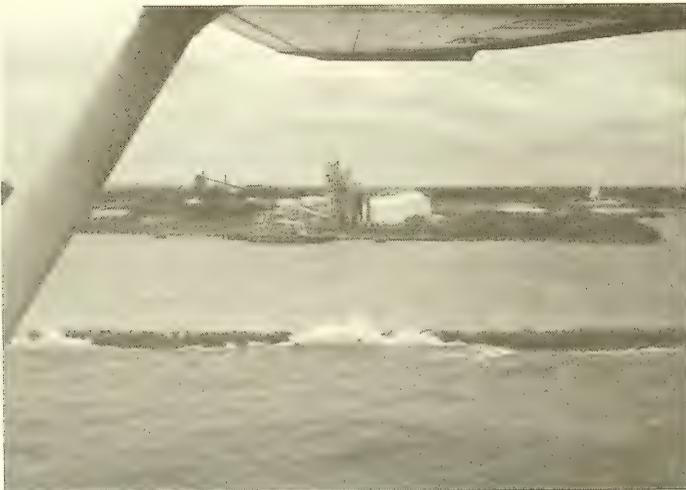
Figure 8. Wave action against breakwater at Burns Harbor, Indiana, April 1986

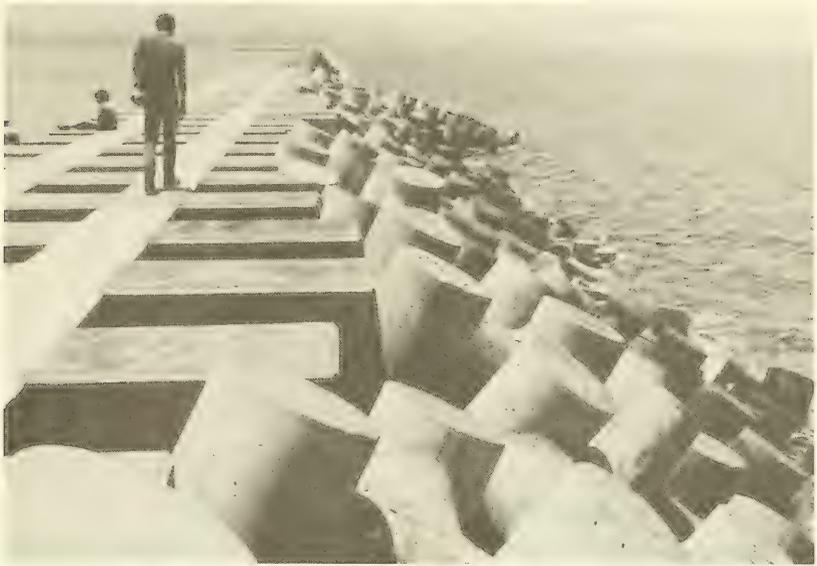
Figure 9. Rib cap on breakwater at Hilo, Hawaii

13. A physical method developed within the US Army Engineer Division, Pacific Ocean, to cope with crown stability and overtopping during heavy wave overtopping of rubble mounds is a ribbed concrete cap. Concrete armor units key into the ribs and improve the stability of the crest, and the presence of the ribs adds resistance to wave overtopping flow thereby reducing transmission (Markle 1982 and Markle and Herrington 1983). Figure 9 shows the concrete rib cap on the breakwater at Hilo, Hawaii. The reef transmission model is not applicable to concrete cap breakwaters without further experimental work.

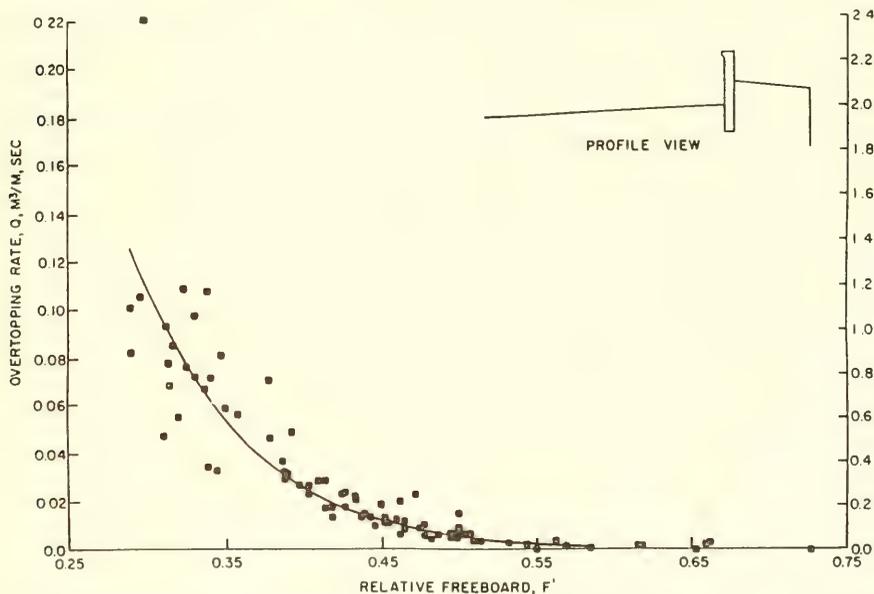
Figure 10. Overtopping rate versus relative freeboard for the Roughans Point seawall with no revetment (configuration RP-1)

17. A very valuable characteristic of the freeboard parameter is that it combines a lot of information about the structure, water depth, and wave conditions into one variable. The parameter  $F'$  has higher correlation with the overtopping rate for the Roughans Point data than any other parameter which could be identified, including the parameter  $F/H_{mo}$ , suggested by the work of Goda (1969) and Seelig (1980) or the dimensionless freeboard parameter  $F/(T_z^2 g H_s)$  used by Owen (1982b), where  $T_z$  is the zero-crossing wave period,  $g$  is the acceleration of gravity and,  $H_s$  is the significant wave height of the spectrum. Figure 10 shows a plot of the overtopping rate as a function of

F' for the existing seawall configuration at Roughans Point without a riprap revetment protecting the wall. Considering the complexity of the irregular wave overtopping process, the ability of F' to consolidate the overtopping data into a well-defined trend is surprising.

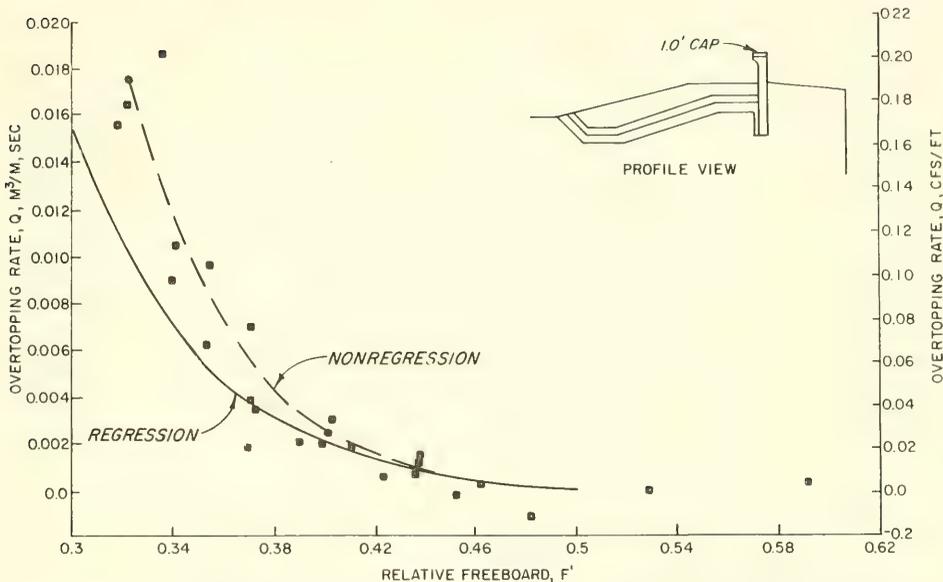
Figure 11. Overtopping rate versus relative freeboard for the Roughans Point seawall fronted by a wave absorber revetment with a berm and a 1.0-ft cap on wall (configuration RP-7)

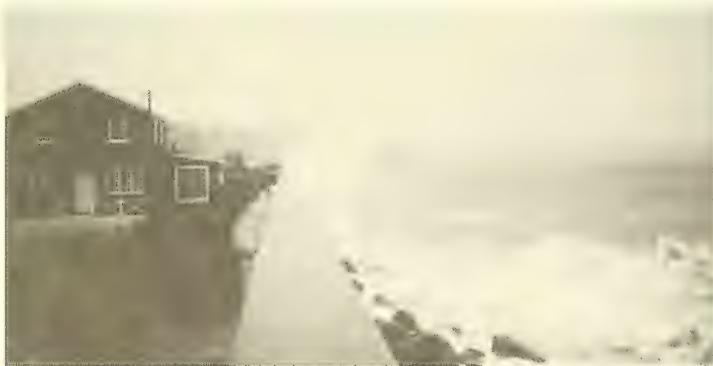
Figure 12. Wave overtopping the seawall at Roughans Point, Massachusetts

21. One method to reduce wave overtopping is to use a recurved wall instead of a vertical wall. The Roughans Point seawall is vertical with a small recurve at the crest. Observations indicate that the recurve is effective when the waves are small enough and the water depth at the wall great enough to allow a reasonably coherent standing wave system to be established. This system causes a vertical flow regime at the wall which is thrown seaward by the recurve (Figure 12). The recurve is not effective when the crest

height of the incident wave approaches the elevation of the crest of the seawall because the large, partial clapotis which forms for a moment in front of the wall then spills over in large volumes of "green" water literally inundating the seawall for a short time.

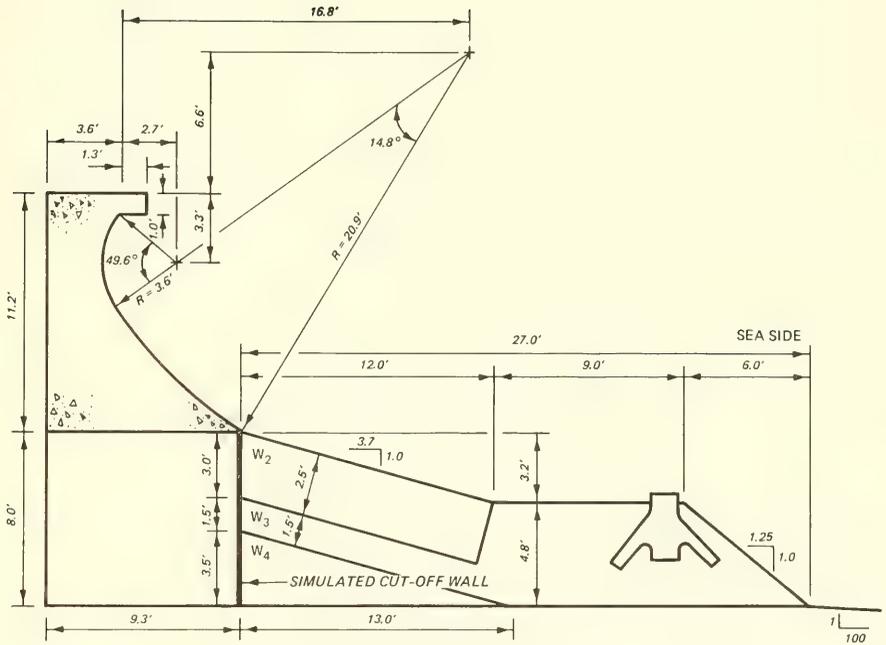
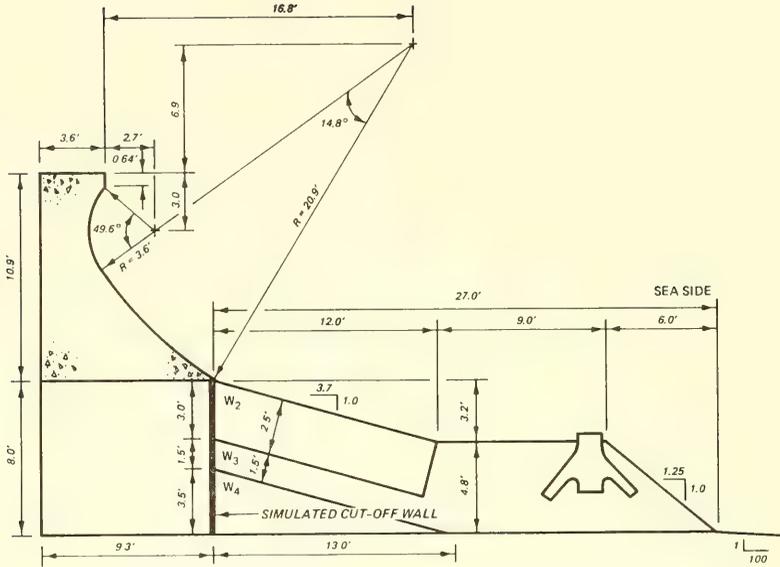
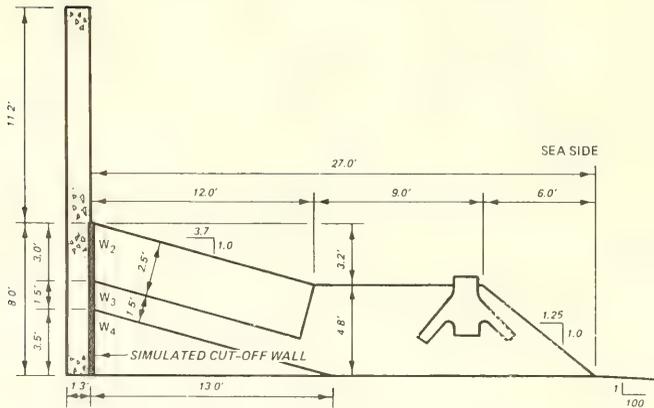
a. Configuration designation CH-1

Figure 13. Cape Hatteras seawall configurations (Continued)

b. Configuration designation CH-2

c. Configuration designation CH-3

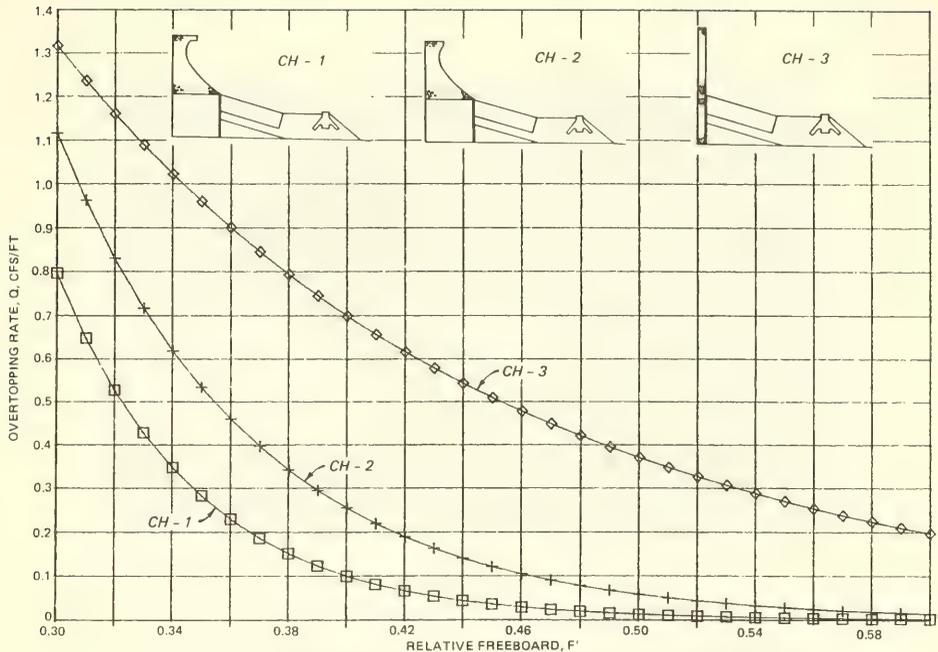
Figure 14. Comparison of overtopping trend curves for the three Cape Hatteras seawall/revetment configurations (CH-1, CH-2, and CH-3)

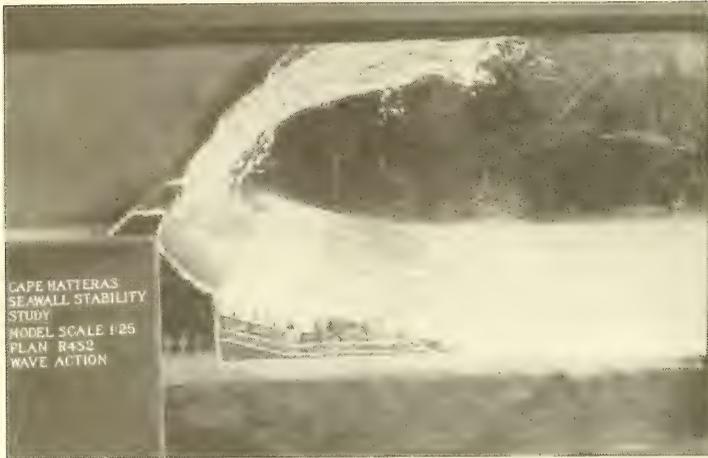
Figure 15. Laboratory tests of wave action against a Cape Hatteras seawall with a moderate recurve

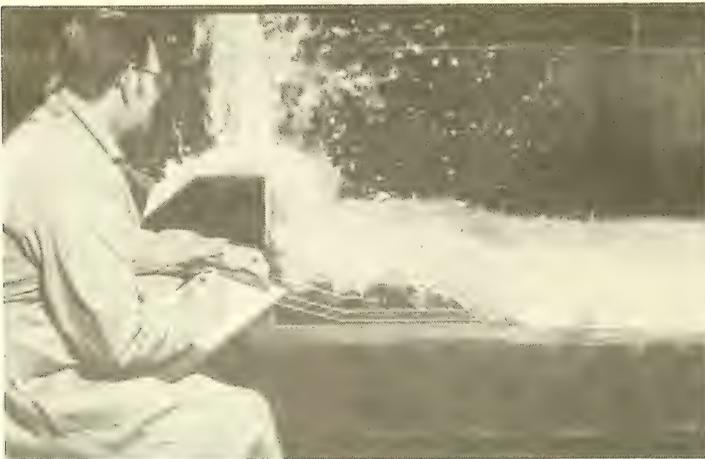
Figure 16. Laboratory tests of wave action against a Cape Hatteras seawall, vertical configuration

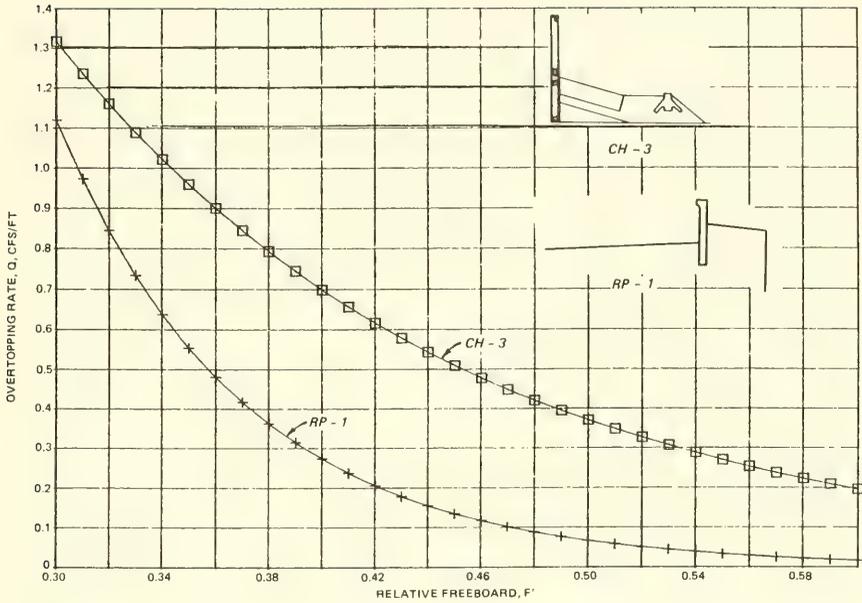
Figure 17. Comparison of overtopping trend curves for the Roughans Point seawall with no revetment (configuration RP-1) and the Cape Hatteras vertical seawall (configuration CH-3)

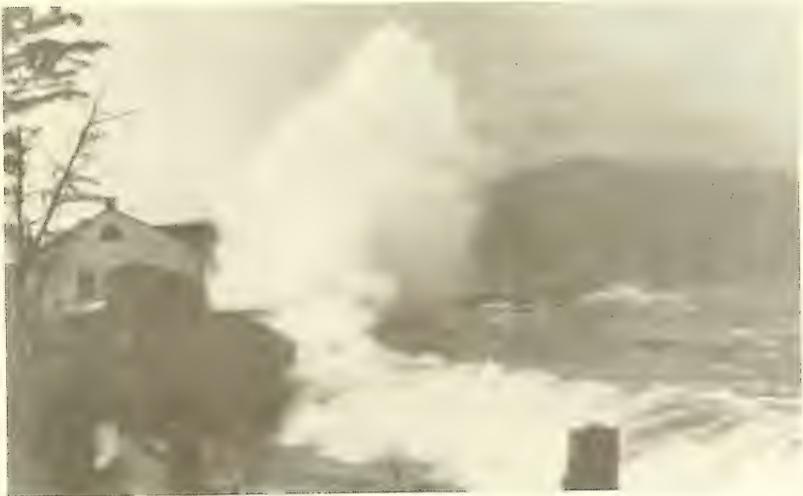
Figure 18. Storm wave action against a revetment at Nesh Bay, Washington, Nov 1948

23. Data analysis of the seawall/revetment configurations referred to as the Cape Hatteras types is in a preliminary stage. This test series includes both vertical and recurved seawalls which have rather extensive revetment toe protection (Figure 13). Overtopping data trend curves of the form of Equation 2 are used in Figure 14 to compare the performance of the three Cape Hatteras seawall/revetment configurations. The poor performance of the vertical seawall compared to the walls with recurvature is clearly shown in Figure 14. Figures 15 and 16 show laboratory tests of the Cape Hatteras seawalls with a typical curve and a vertical wall, respectively, that illustrate the considerable difference in wave action that can occur at the wall for different structure geometries. It can be seen in Figure 14 that the wall with severe recurvature is somewhat better than the wall with more moderate recurvature. In Figure 17, the overtopping trend curves for the Roughans Point seawall profile shown in Figure 10 are compared to those for the vertical wall Cape Hatteras profile shown in Figure 13. Figure 17 indicates that even a rather small recurve can be effective since the Roughans Point overtopping trend curve falls considerably below the corresponding curve for the vertical Cape Hatteras seawall configuration. Figures 14 and 17 illustrate the value of the overtopping model, defined by Equations 1 and 2, for evaluating the performance of a single configuration and for making comparisons between and among configurations. It should be noted that Equation 2 does not take into account water blown over the wall by onshore winds which are usually present during overtopping conditions. Therefore, a recurve which throws water seaward and possibly even downward will control windblown overtopping better than a vertical wall that throws the water straight upward. Figure 18 shows how energetic wave action can send large quantities of spray to impressive heights when waves encounter a steep barrier. Figure 18 was taken at Neach Bay, Washington, with long-period waves propagating shoreward from the Strait of Juan de Fuca and crashing against a riprap revetment with a slope of 1 on 2.

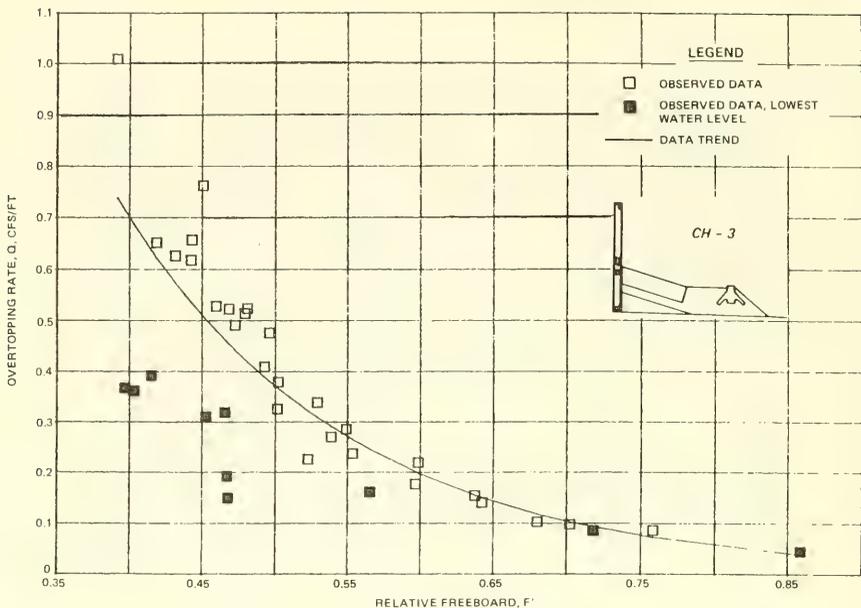
Figure 19. Overtopping rate versus the relative freeboard for the Cape Hatteras vertical seawall (configuration CH-3)

Cape Hatteras seawall provides an illustration of the effectiveness of toe protection rubble in reducing overtopping of the wall. Figure 19 shows overtopping data for the Cape Hatteras profile with a vertical wall. A number of the data points fall conspicuously below the overtopping trend established by regression analysis. Analysis of the data indicates that these points are all associated with the lowest water level tested. Since the dimensionless freeboard defined by Equation 1 takes the water level into consideration, data collected at all water levels should all follow the same trend in figures like Figure 19 unless there is a strong influence from another factor. Additional analysis indicates that when there is relatively shallow water over the rubble toe protection the rubble is quite effective in dissipating wave energy and reducing wave overtopping even when the wall is vertical. However, there appears to be a point when a small increase in water depth will make the toe protection rubble much less effective in reducing overtopping. This effect is demonstrated in Figure 19 where the data collected at the lowest water level

are shown with shaded symbols which follow a trend distinctly lower than that from the data collected at two slightly higher water levels.

26. The performance of the wide berm absorber revetment (configuration 4) in reducing wave overtopping of the seawall can be compared to the overtopping trends for a seawall fronted by a traditional riprap revetment (configuration 2) in Figure 21. Over most of the range of interest, as indicated, the wide berm configuration is better than the standard riprap revetment. The influence of a berm is noted also in discussion of the influence of extensive toe protection used for the Cape Hatteras vertical wall configuration and demonstrated by the data shown in Figure 19. In general, it appears that

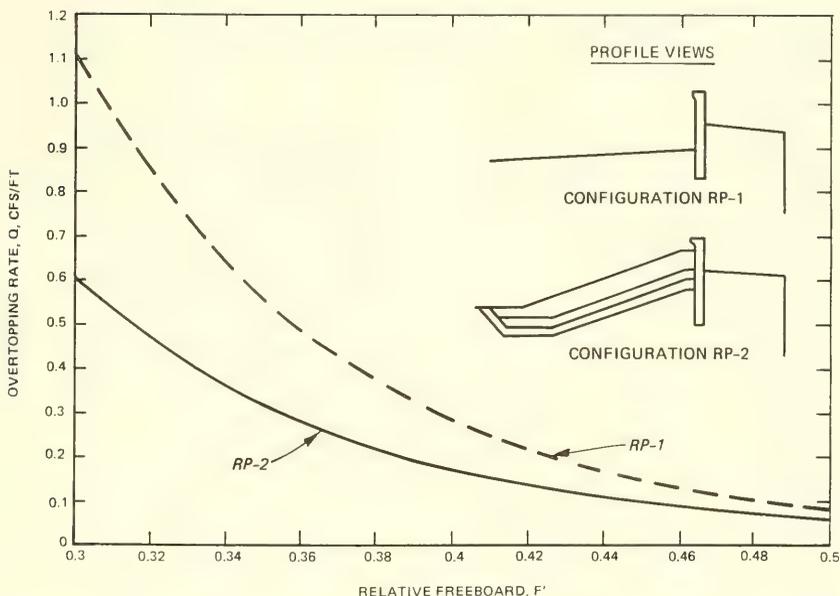
Figure 20. Comparison of overtopping trend curves for the Roughans Point seawall with no revetment (configuration RP-1) and the same seawall fronted by a standard riprap revetment (configuration RP-2)

25. During the Roughans Point study, a standard multilayered riprap revetment was built against the seawall with the top of the revetment near the top of the wall just below the recurve. The revetment reduced the overtopping rates by about 45 percent over the same seawall configuration without a revetment. Figure 20 shows a comparison of the performance of the two configurations using data trend curves developed from regression analysis. Standard riprap revetment was found to be less effective in reducing overtopping than was originally thought. Two possible reasons for the disappointing performance of the riprap were identified:

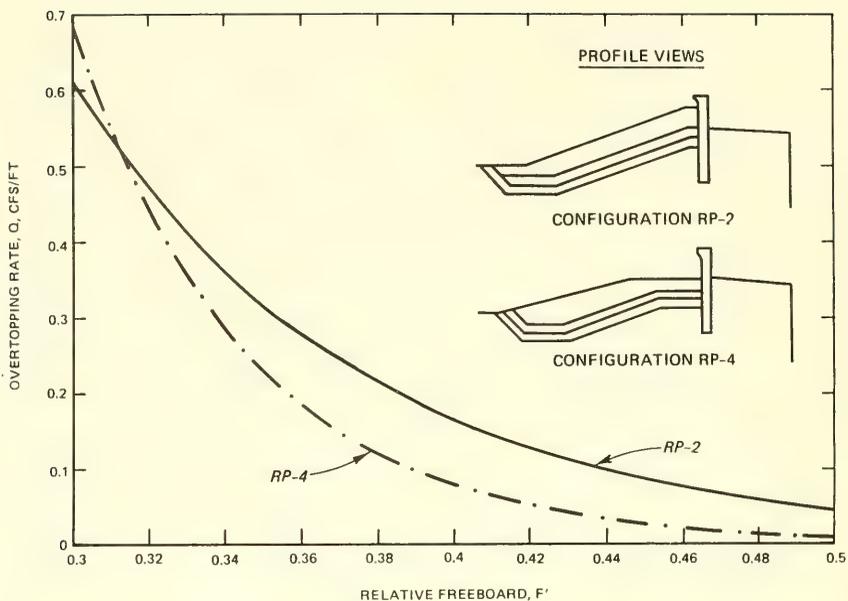
Figure 21. Comparison of overtopping trend curves for the Roughans Point seawall fronted by a standard riprap revetment (configuration RP-2) and the same seawall fronted by a wide berm, absorber revetment (configuration RP-4)

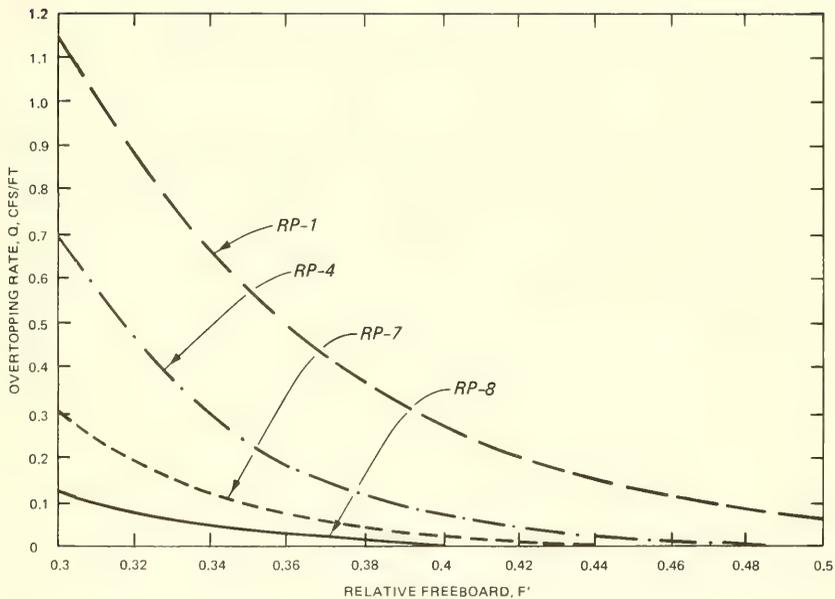
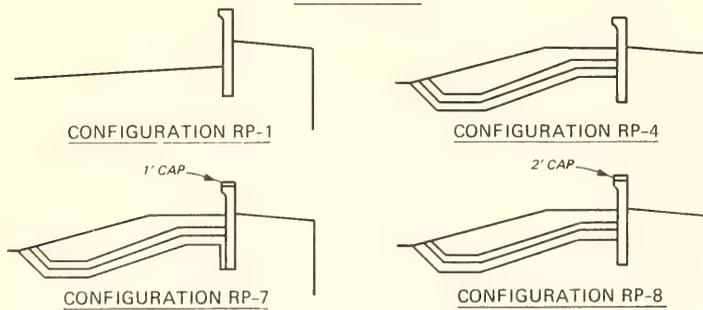
Figure 22. Comparison of overtopping trend curves for configurations RP-1, RP-4, RP-7, and RP-8

27. A fourth method to reduce wave overtopping is to increase the crest elevation of the seawall. Because overtopping rates increase approximately exponentially with freeboard, the value of increasing the height of the wall can be readily appreciated. Tests were conducted during the Roughans Point study using a 1.0-ft cap and a 2.0-ft cap on the seawall. These caps were found to be very effective in reducing overtopping rates. Figure 22 shows overtopping trends for four seawall/revetment configurations, including configuration 7 with a 1.0-ft cap and configuration 8 with a 2.0-ft cap. configurations 4, 7, and 8 have the same wide berm absorber revetment profile so that the effectiveness of a cap can be easily appreciated in Figure 22 by

comparing the overtopping curves. Although in many situations increasing the height of a seawall would be unacceptable, Figure 22 shows that the effectiveness of a cap can be equivalent to placing a great amount of stone in front of the seawall.

31. Methods to alleviate wave overtopping of revetments obviously include increasing the thickness of the armor layer, using a quarry stone overlay (McCartney and Ahrens 1976), or possibly building a berm on the riprap revetments. The value of a berm was discussed under the topic of reducing wave overtopping of seawalls. A parapet could be used on a riprap revetment or a block revetment to reduce overtopping. An extension of the berm concept is to use an offshore breakwater in front of the revetment to reduce the severity of wave action on the revetment (Markle 1981; Powell and Allsop 1985). A modification of the offshore breakwater concept is to incorporate an underwater sill into the toe of the revetment to introduce premature wave breaking. Offshore breakwaters, sills, and berms provide a progression of possible solutions which seem promising for some situations, such as protection of El Morrow Castle, in San Juan, Puerto Rico (Markle 1982), but these solutions generally are expensive compared to the use of a parapet. The value of a parapet is probably similar to the value of a cap in increasing the height of a seawall, as shown in Figure 22.

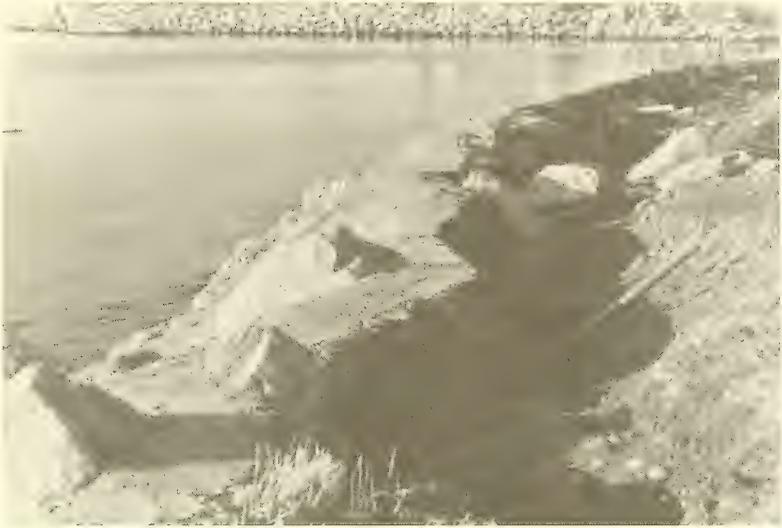
Figure 23. Damage to a grouted riprap revetment at New London, Connecticut, caused by waves generated by Hurricane Gloria, September 1985

30. In some instances wave overtopping of a revetment occurs because the extent of wave runup is underestimated. Figure 23 shows a riprap revetment in New Haven, Connecticut, which was overtopped by wave action caused by Hurricane Gloria in 1985. Grouting of this riprap might have made the wave runup problem worse by making the revetment effectively smoother and thereby increasing the amount of overtopping. Ponding due to overtopping creates a hydraulic head which will cause fine particles to migrate out through the revetment if filter layers are not properly constructed. Loss of fine material from behind the revetment will eventually cause a collapse of the structure. A similar problem is shown in Figure 24 where storm waves from Hurricane Hilda (1964) overtopped the west jetty at Panama City, Florida. Ponding behind the jetty caused sand to migrate through the structure creating "sink" holes. Generally, small amounts of sand loss are not a problem since a jetty is free standing, but deep sink holes could undermine the heel of the jetty and cause the structure to slump.

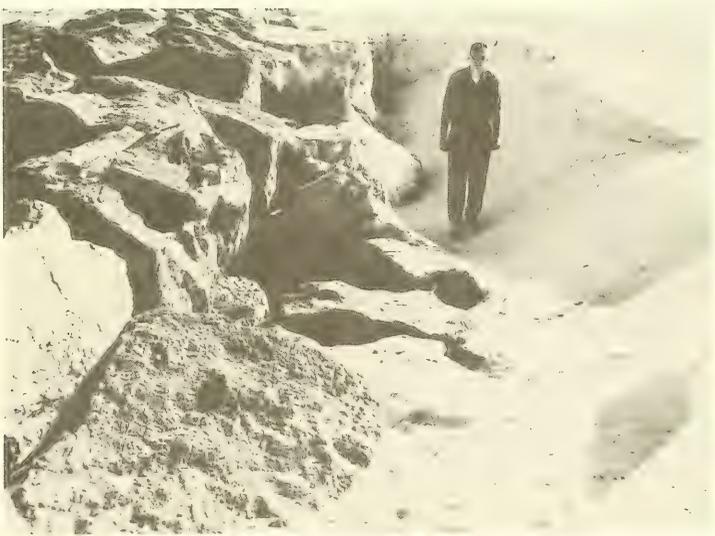
Figure 24. Damage to grouted riprap revetment at Panama City, Florida, caused by waves generated by Hurricane Hilda, October 1964
